**REPORT NO. 05-12**

**TRANSPORTABILITY TESTING  
OF THE JOINT DIRECT ATTACK MUNITION (JDAM) PACKED  
IN A CNU-589 SHIPPING AND STORAGE CONTAINER  
USING VINYL DUNNAGE AIR BAGS,  
TP-94-01, REVISION 2, JUNE 2004  
“TRANSPORTABILITY TESTING PROCEDURES”**

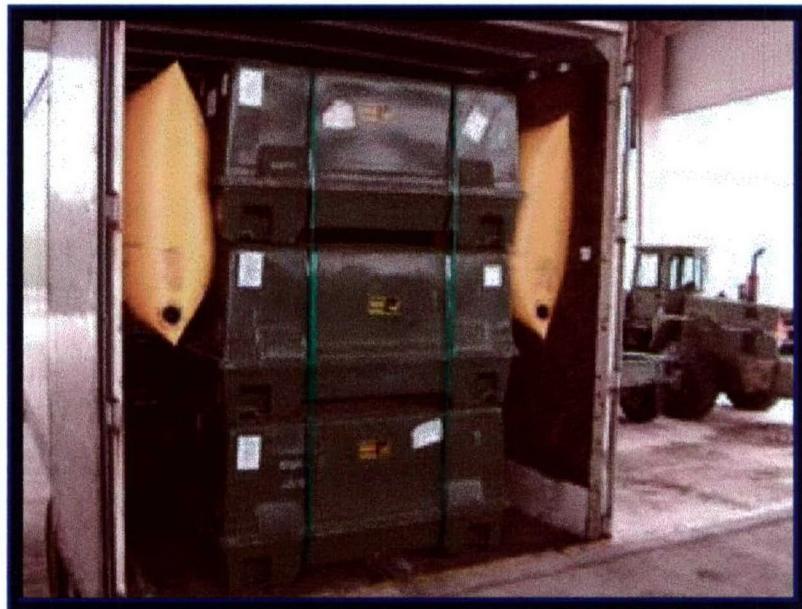
**Photo 1. Air Bags Securing the JDAM CNU-589 Containers**

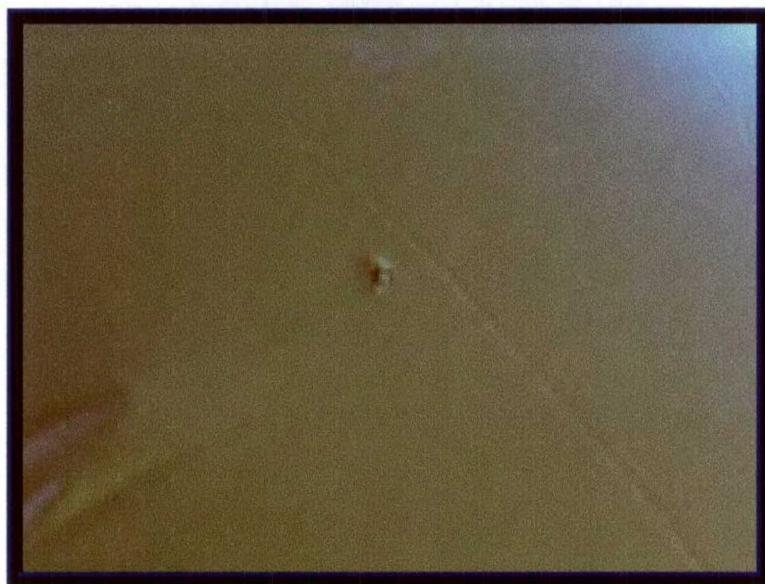
- b. Both air bags on the door end had fallen out of position due to the containers shifting from damage to the JDAM CNU-589 containers. The JDAM CNU-589 containers were damaged due to the absence of lateral strapping to prevent movement. Both air bags at the door end had holes due to a puncture from the damaged JDAM CNU-589 containers and from previous damage to the trailer liner. The air bags held the undamaged JDAM CNU-589 containers in place throughout the trailer. The interface between the air bags and the JDAM CNU-589 containers with steel strapping was examined. No damage was caused to the air bags due to the steel strapping.

**Photo 4. Damaged Air Bag.**

Additional polyester strapping should be added to the door end stack of JDAM CNU-589 containers to prevent movement in the lateral direction. This is applicable to when the stack is loaded at the door end in the lateral direction, as tested. The door end stack should be strapped to prevent movement in both the lateral and longitudinal direction.

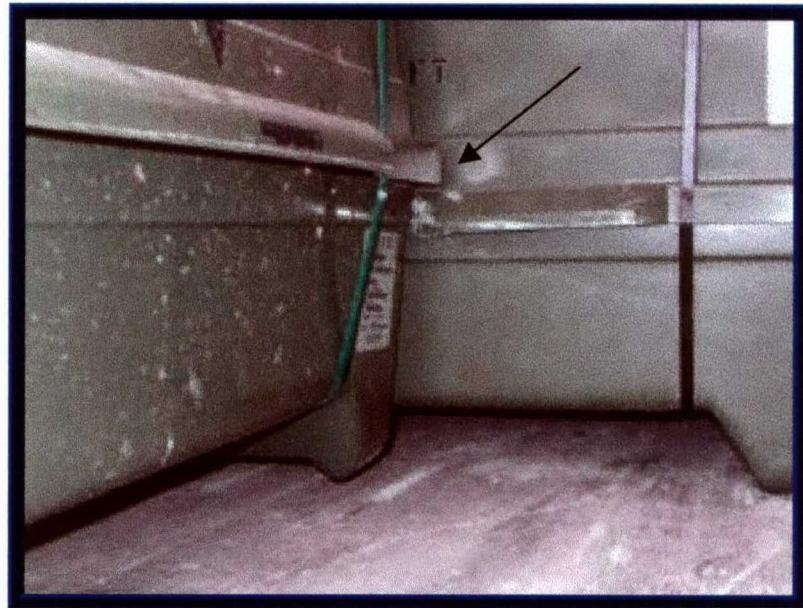
1. The JDAM CNU-589 container stack at the door end of the container had stair cased onto the next row of the JDAM CNU-589 containers.
2. The passenger side air bag at the door end had moved but was still adequately restraining the load.
3. The payload had moved laterally toward the driver's side at the door end.
4. The JDAM CNU-589 containers had moved 8 inches from the closed wall of the trailer due to the stair casing of the JDAM CNU-589 container lid handles.

**Photo 5. Stair Casing of JDAM CNU-589 Container Lid Handles.**

**C. RECOMMENDATION:** Doubled 2" x 6" nailed floor line dunnage should be placed between each JDAM CNU-589 container stack to prevent stair casing and movement in the longitudinal direction.

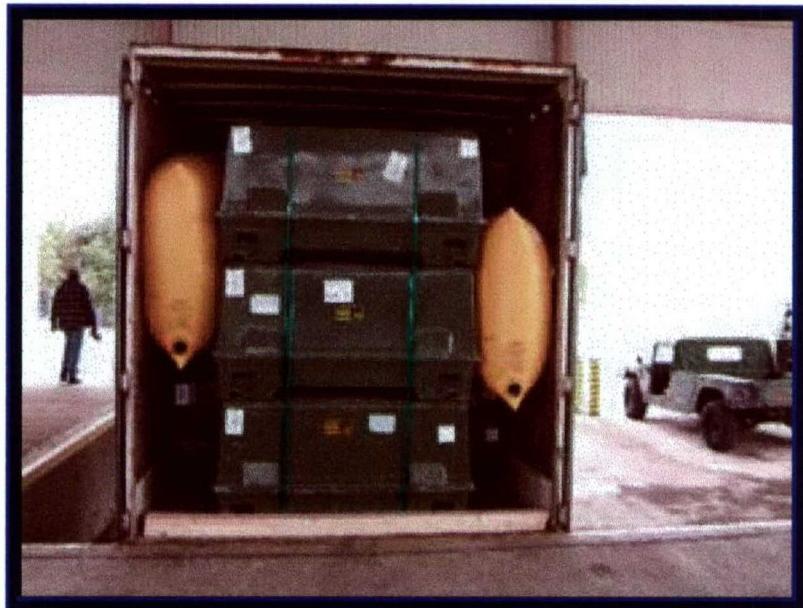
**Photo 6. Movement of Passenger Side Air Bag.**

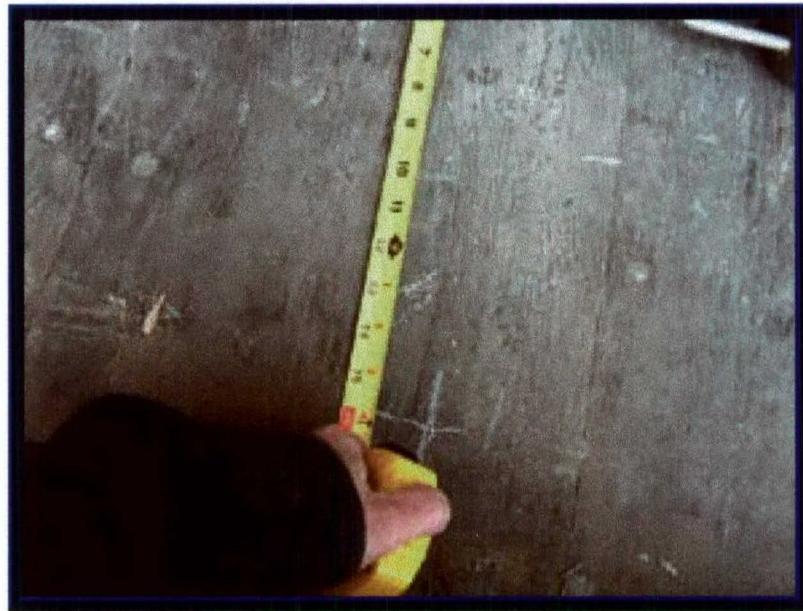
2. During the forward 5 mph panic stop the JDAM CNU-589 containers moved 7.5 inches in the forward direction due to the stair casing of one JDAM CNU-589 container onto another.
3. During the forward 10 mph panic stop the JDAM CNU-589 containers moved an additional 4.5 inches in the forward direction due to the stair casing of one JDAM CNU-589 container onto another.
4. During the forward 15 mph panic stop the JDAM CNU-589 containers moved forward an additional 3.5 inches on the driver's side and back 1.5 inches on the passenger side due to the stair casing of one JDAM CNU-589 container onto another. The total movement was 15.5 inches from the original starting position on the driver's side.
5. The payload was not examined following the reverse 5 mph due to the pressure the payload exerted on the trailer doors.

**Photo 7. 15.5 Inches Total Movement from the Original Starting Position.**
